# Inspection Report

## Happy Homeowner

45 Oak Dr.

<b>Date:</b> 2/21/2012	<b>Time:</b> 2:30 PM	<b>Report ID:</b> WCJ1202C019
<b>Property:</b> 45 Oak Dr. Charleston SC 29401	<b>Customer:</b> Happy Homeowner	<b>Real Estate Professional:</b>

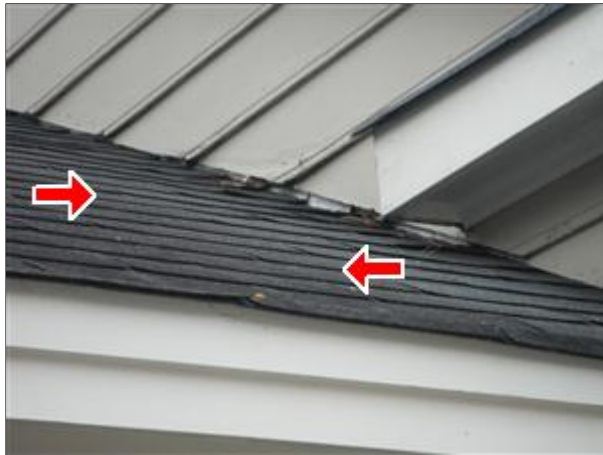
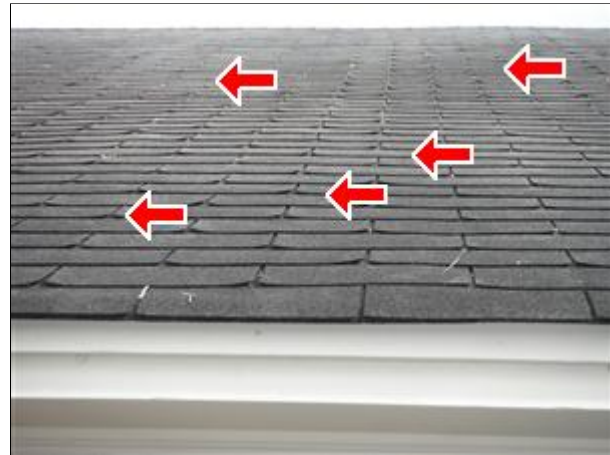
**1.0** Shingles old , curling up on the edges, old roof in worn condition.

Old roof covering in worn condition.

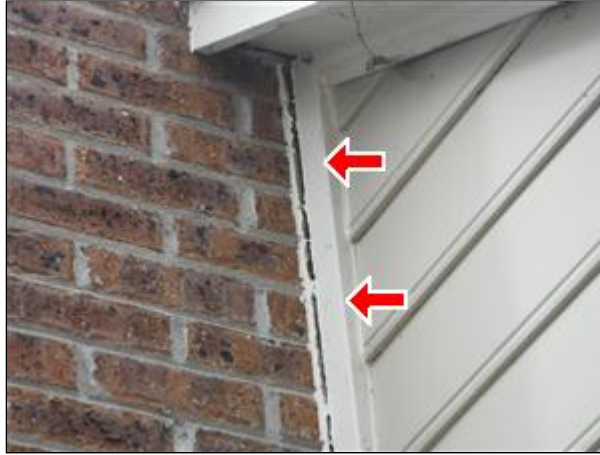
1.2 Picture 1

1.2 Chimney has settled , pulling away from the side of the house.

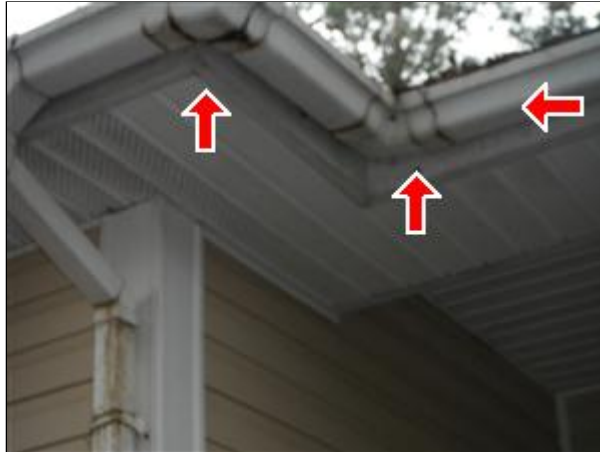
1.3 Picture 1

1.3 Gutters show signs of leaks at the joints.

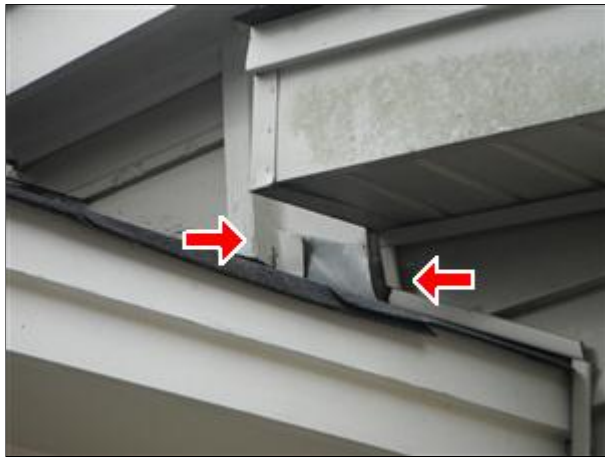
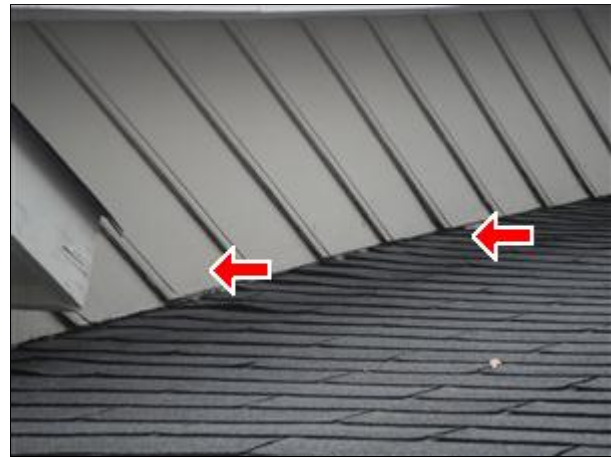
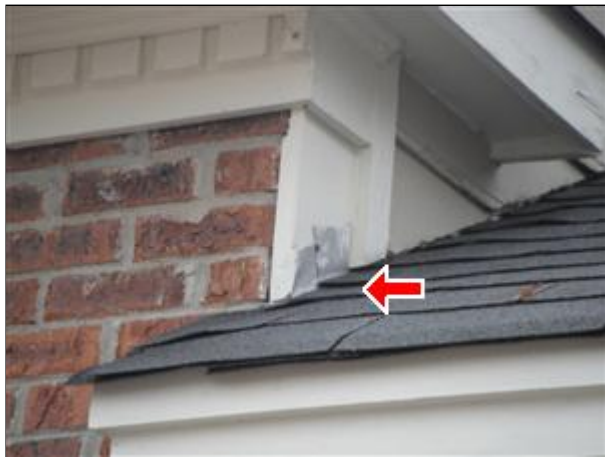
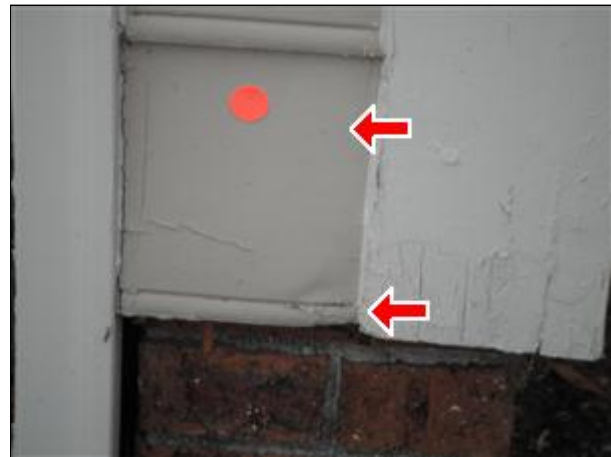
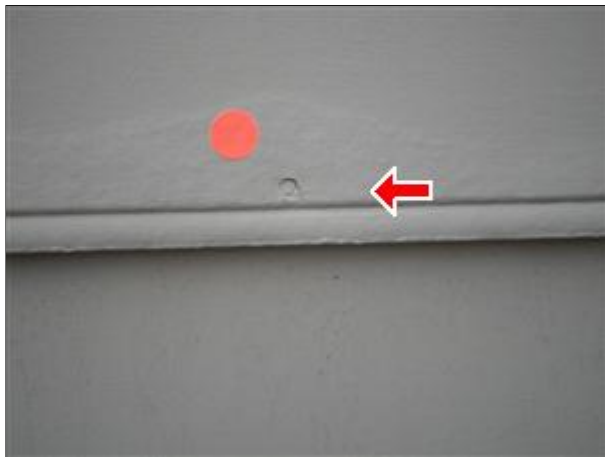
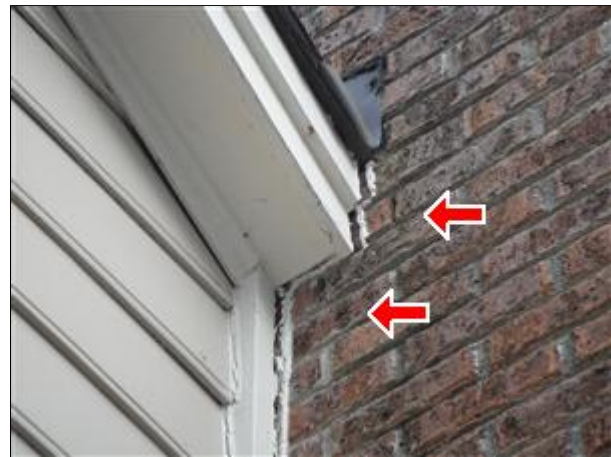
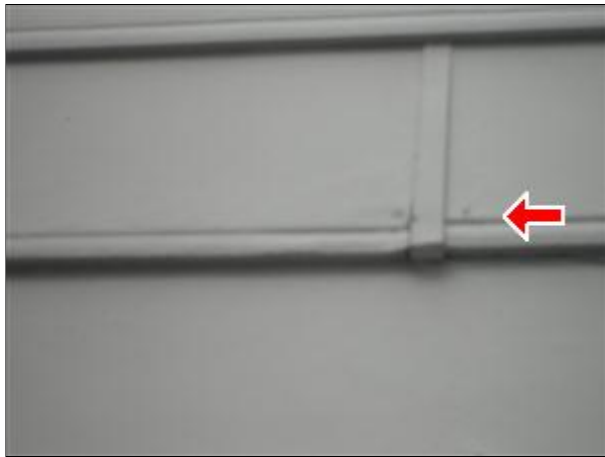
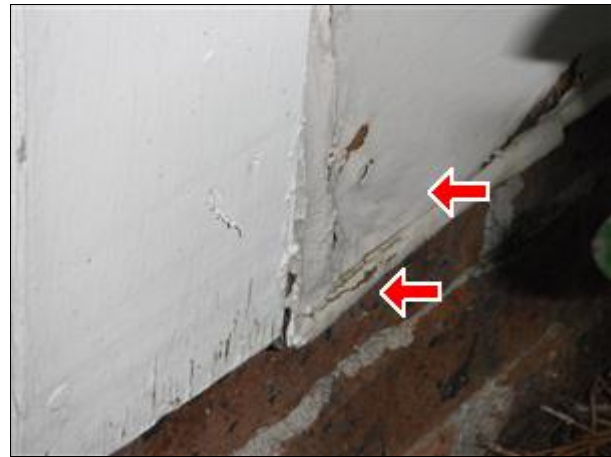
Shingles , siding doesn't have any clearance. Can cause some damage to the siding.

Chimney has settled, pulling away from the house, needs evaluation and repairs by a Qualified Lic. Contractor.

Hardboard siding is damaged from moisture on the rear of the home.

Hardboard siding is damaged on the left front corner.

Siding damaged from moisture on garage.

Hardboard siding is damaged on right side of the garage

Hardboard siding has small damaged areas where siding touches the shingles

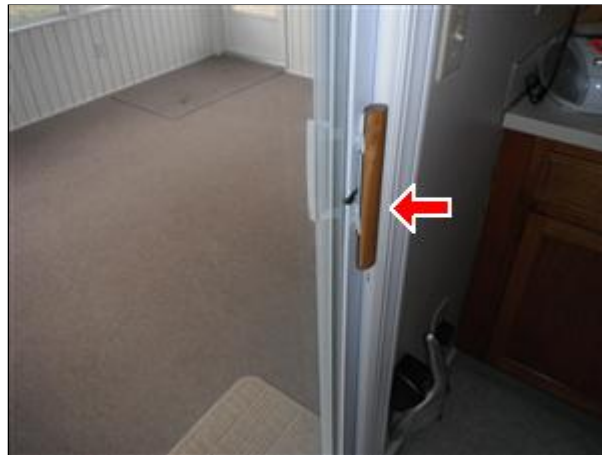
2.1 Picture 1

2.1 Rear slider door lock, latch needs adjustment.

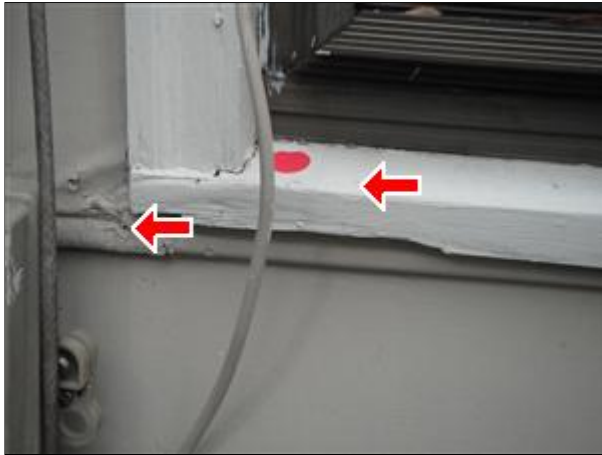
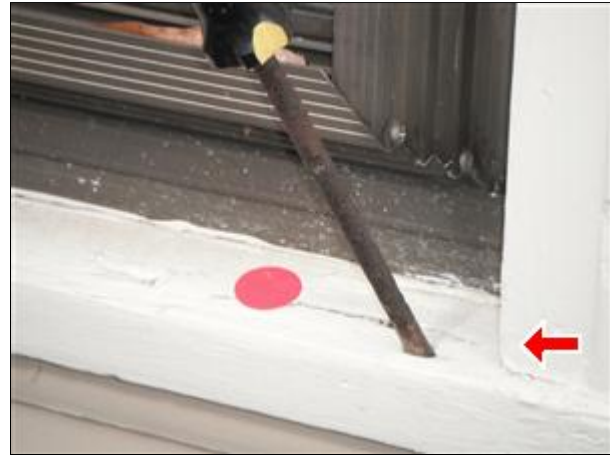
2.2 Window sill and siding is damaged on the lefty side of the house from moisture.

Window sill damaged from moisture on left side of the house..

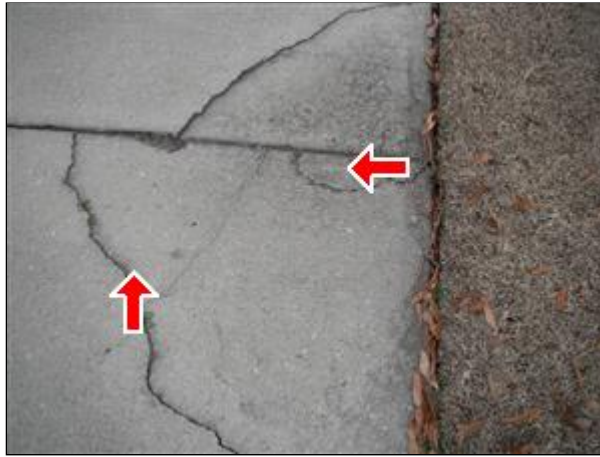
2.4 Picture 1

## 2.4 Driveway cracked up and uneven.

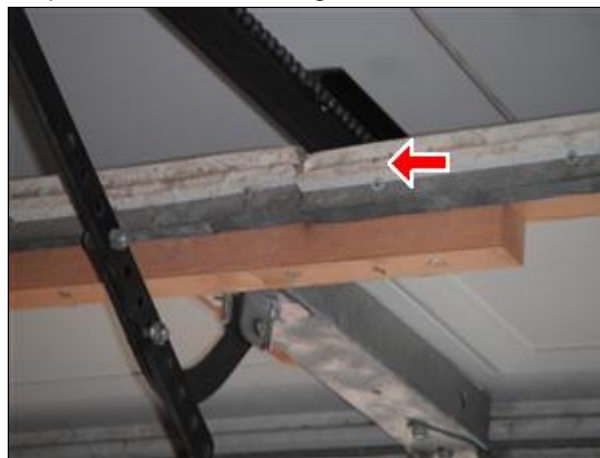
3.3 Picture 1

**3.3 Garage door metal panel , at the top of the door , is damaged**

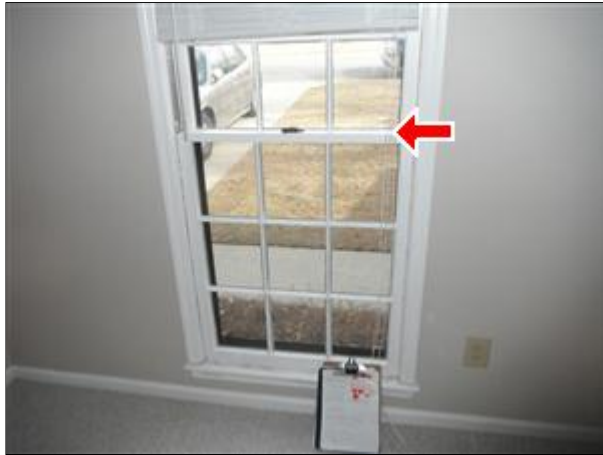
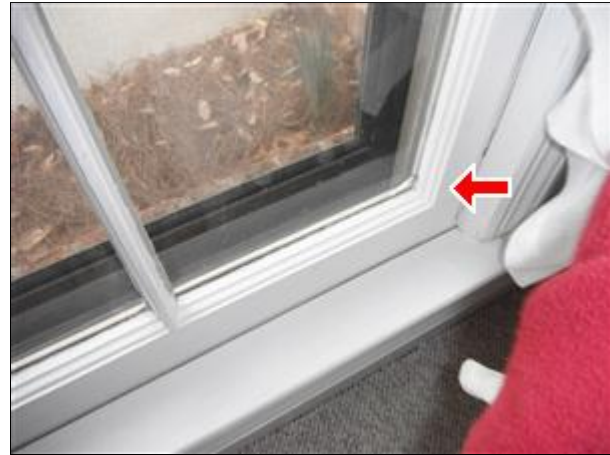
4.6 Front right bedroom window is stuck shut, won't open.

Front left bedroom window has a cracked window pane.

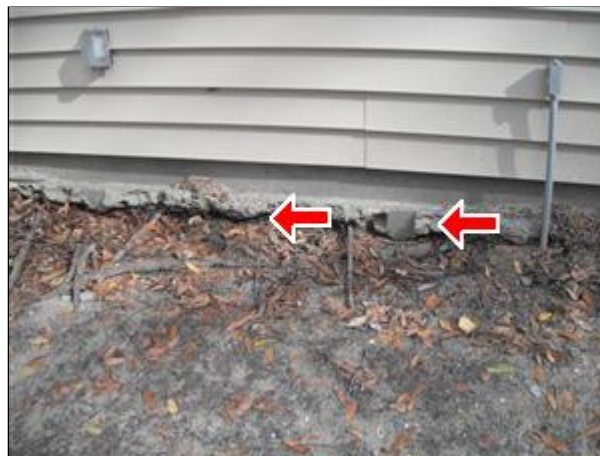
5.0 Picture 1

**5.0** Rear sun room slab exposed , footings , needs backfilling with soil.

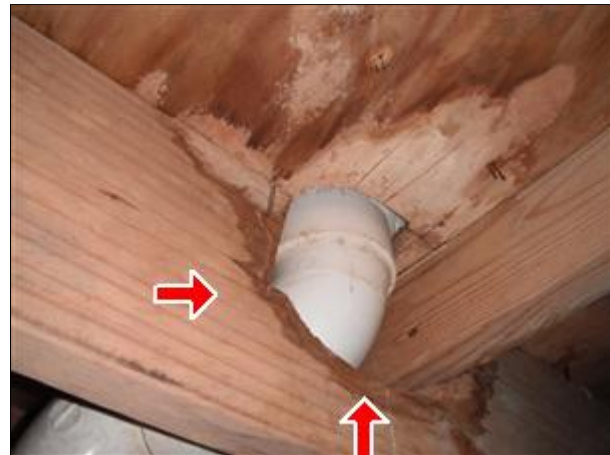
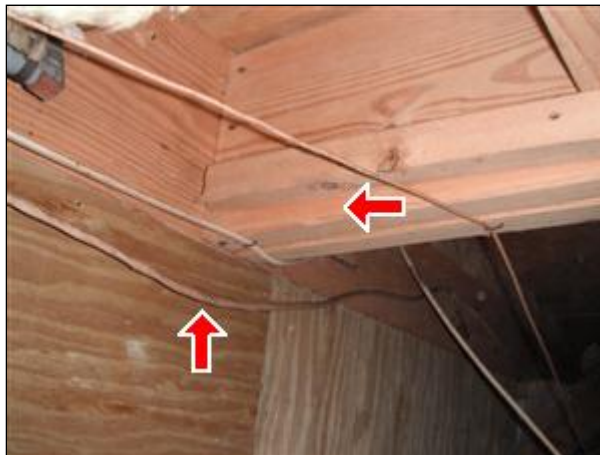
**5.3** Floor system damaged

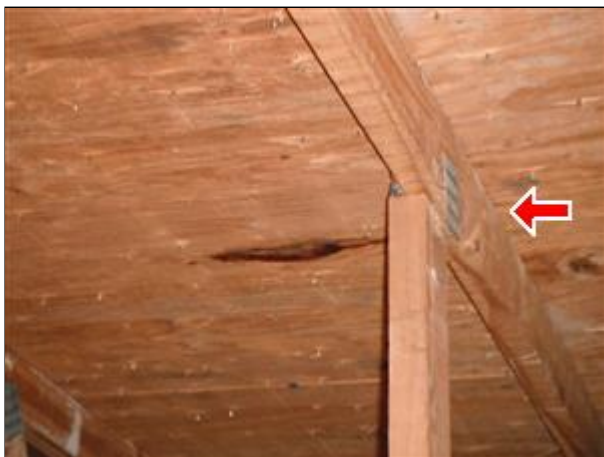
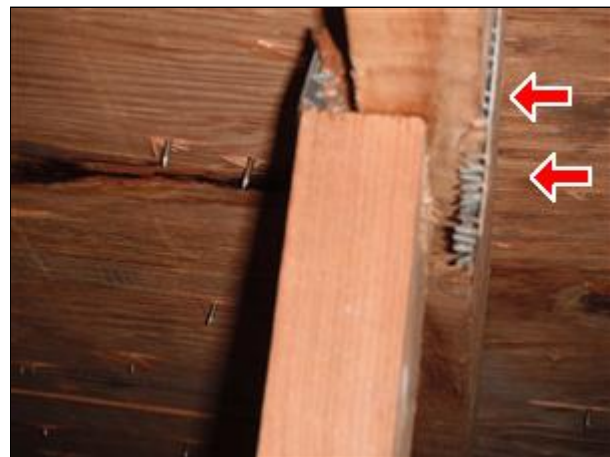
5.5 Truss framing in attic has a damaged metal truss gang nail plate, needs evaluation by a Lic. Engineer for any repairs.

Truss connection loose in attic.

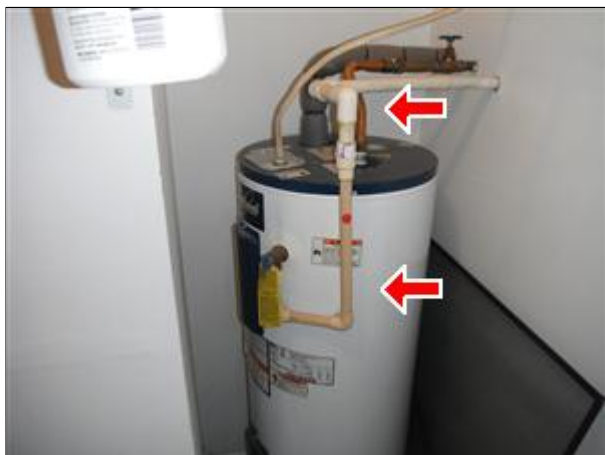
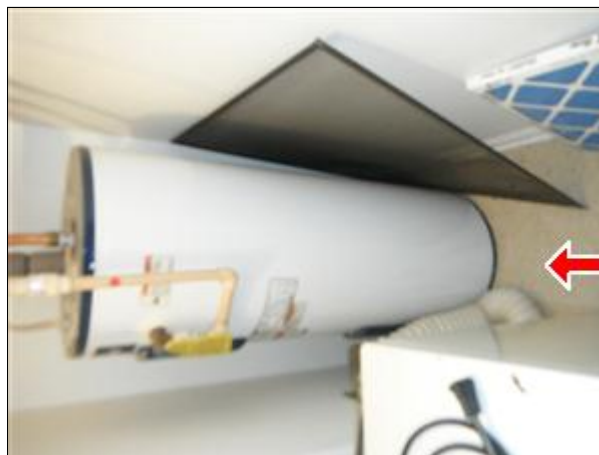
6.0 Water heater PRV drain line goes uphill , should be vented downhill.

No drip pan under water heater , without a drip pan , if the water heater leaks water will cause damage to the floor covering and wood trim

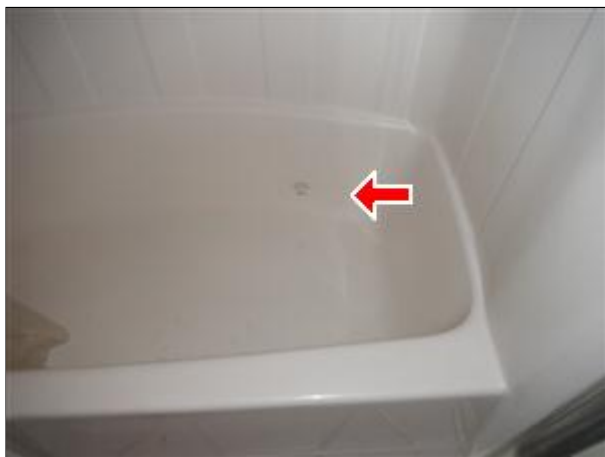
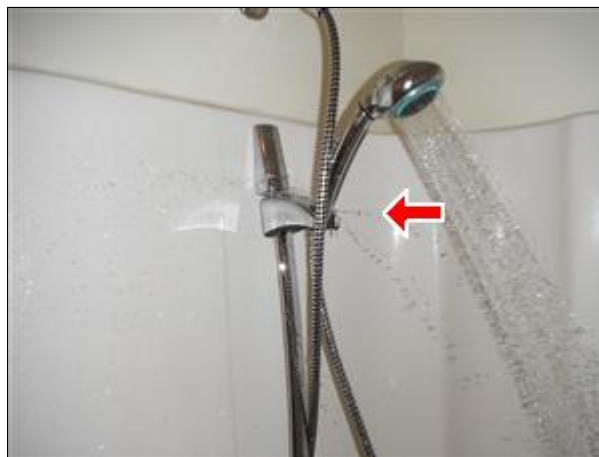
6.1 Old repaired area in master bathtub.

Mbath tub shower head leaks at the connection.

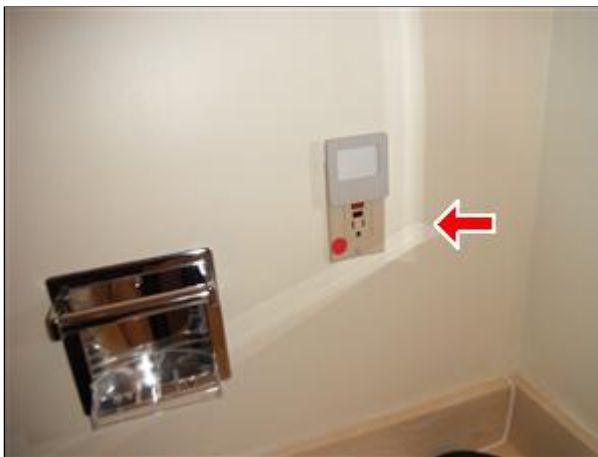
7.5 Picture 1

**7.5 Master bath GFCI wall receptacle trips into the hall bath , needs to be corrected**

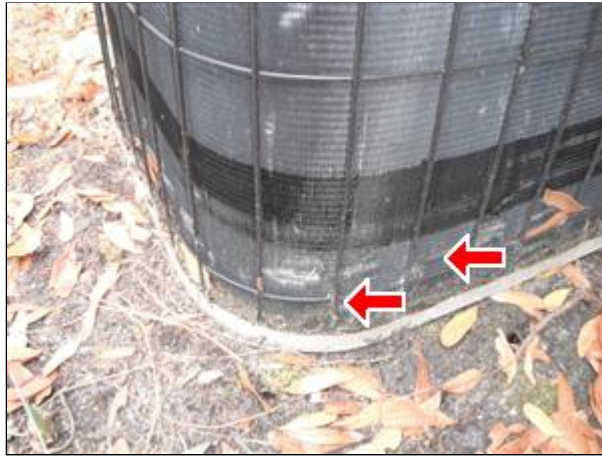
8.0 Picture 1

8.0 Outside unit fins have some damage.

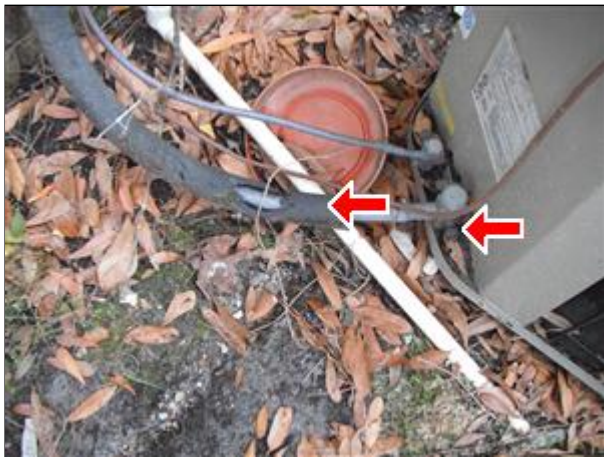
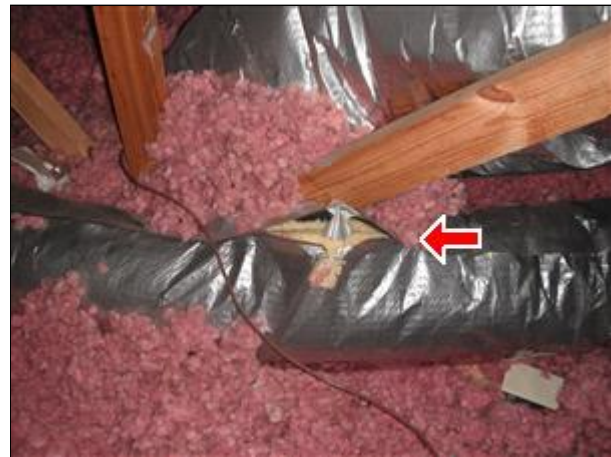
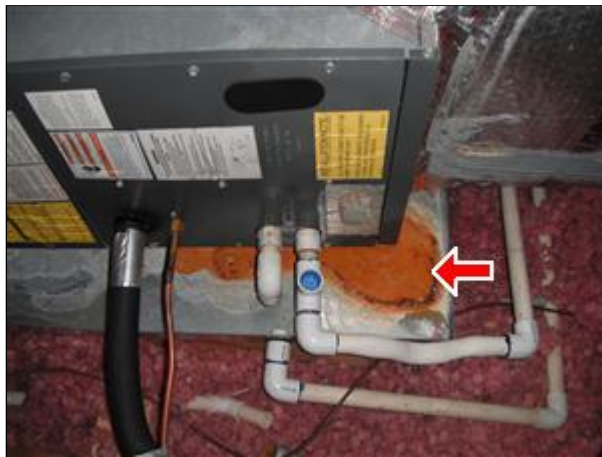
8.3 Outside compressor unit refrigerant line insulation is damaged.

Attic ductwork insulation is damaged , needs resealing.

Attic drip pan under the unit has some rusty areas in the pan.

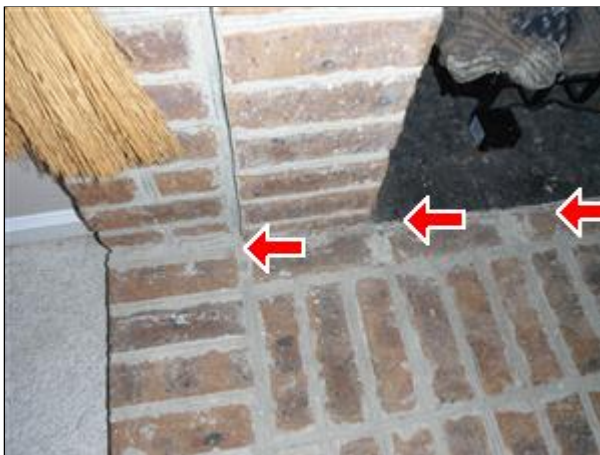
8.5 Picture 1

## 8.5 Brick hearth has settlement cracks in the grout.

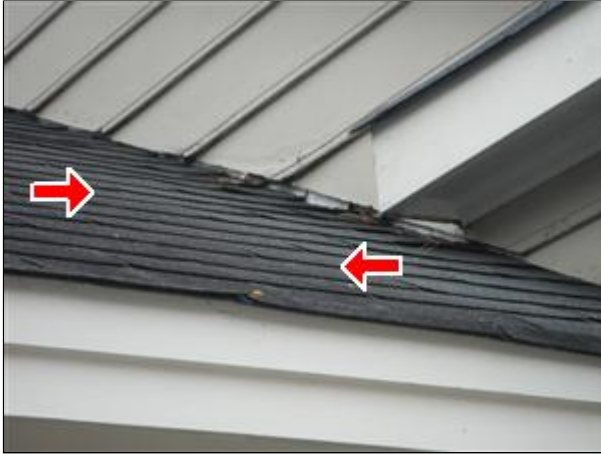
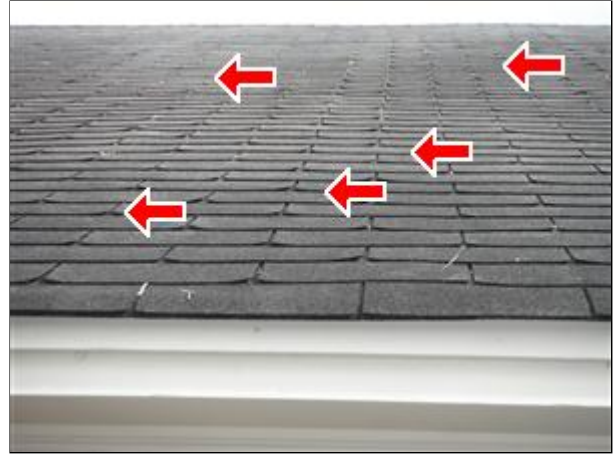
Shingles old , curling up on the edges, old roof in worn condition.

Old roof covering in worn condition.

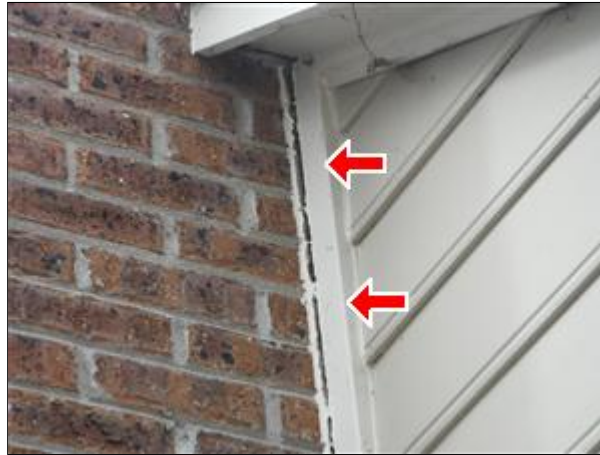
1.2 Picture 1

Chimney has settled , pulling away from the side of the house.

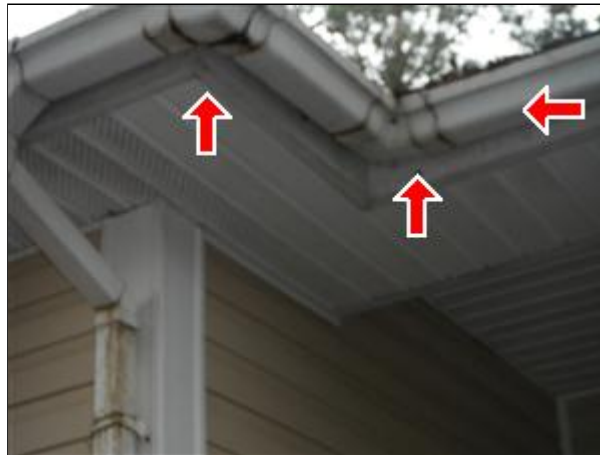
1.3 Picture 1

Gutters show signs of leaks at the joints.

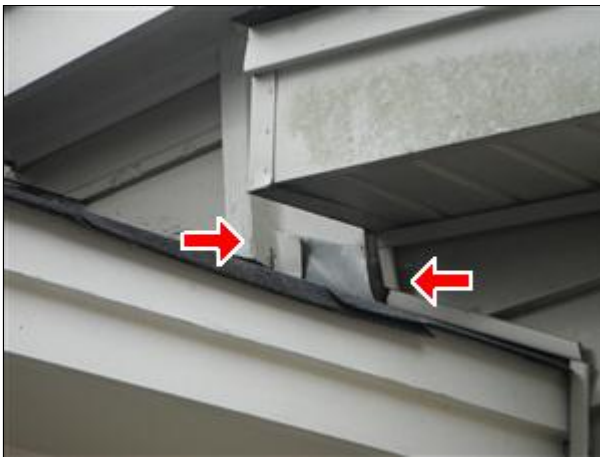
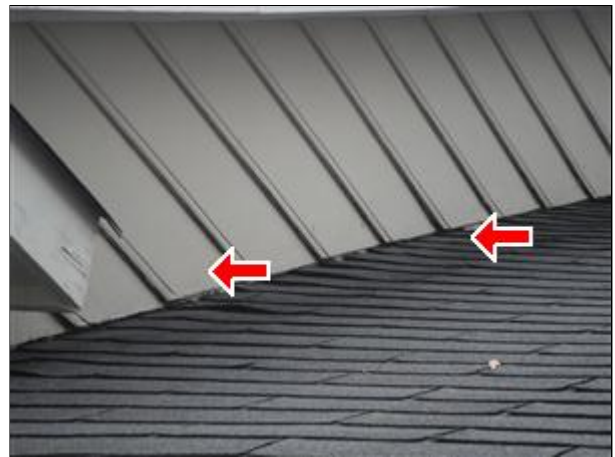
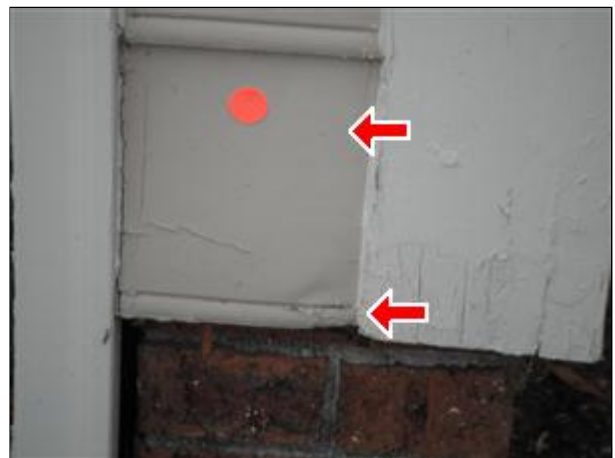
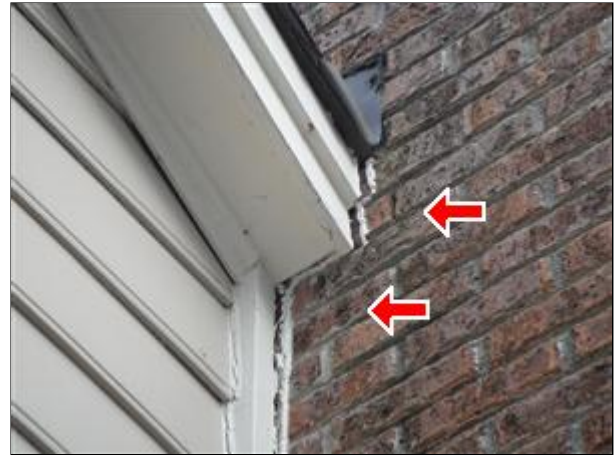
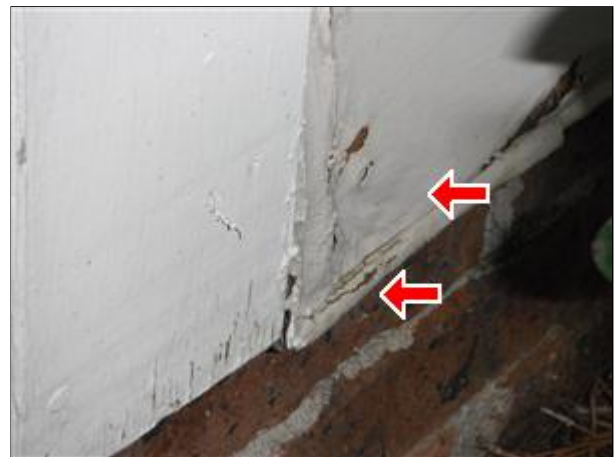
Shingles , siding doesn't have any clearance. Can cause some damage to the siding.

Chimney has settled, pulling away from the house, needs evaluation and repairs by a Qualified Lic. Contractor.

Hardboard siding is damaged from moisture on the rear of the home.

Hardboard siding is damaged on the left front corner.

Siding damaged from moisture on garage.

Hardboard siding is damaged on right side of the garage

Hardboard siding has small damaged areas where siding touches the shingles

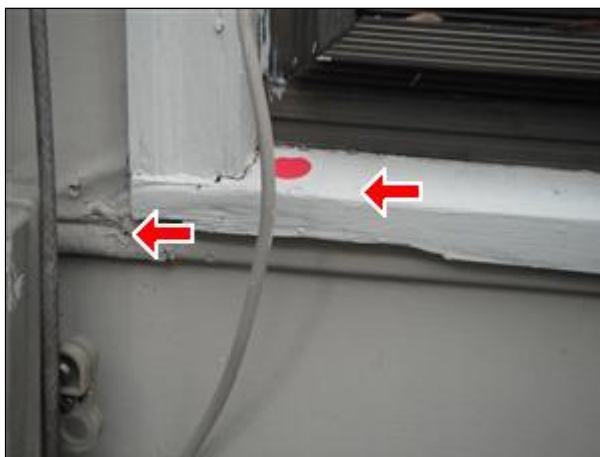
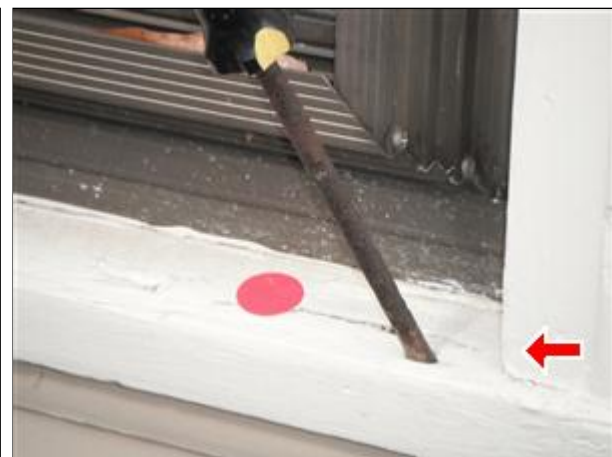
Window sill and siding is damaged on the lefty side of the house from moisture.

Window sill damaged from moisture on left side of the house..

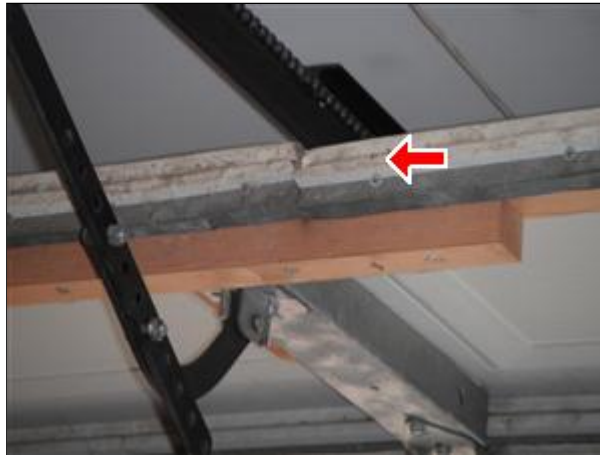
3.3 Picture 1

Garage door metal panel , at the top of the door , is damaged

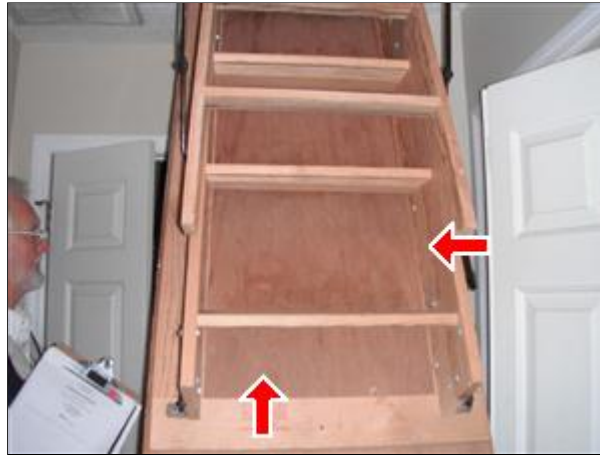
4.3 Picture 1

Attic pull down steps not insulated or weather-stripped.

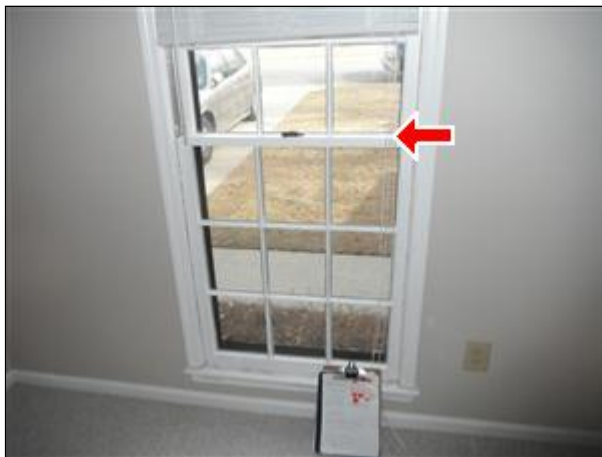
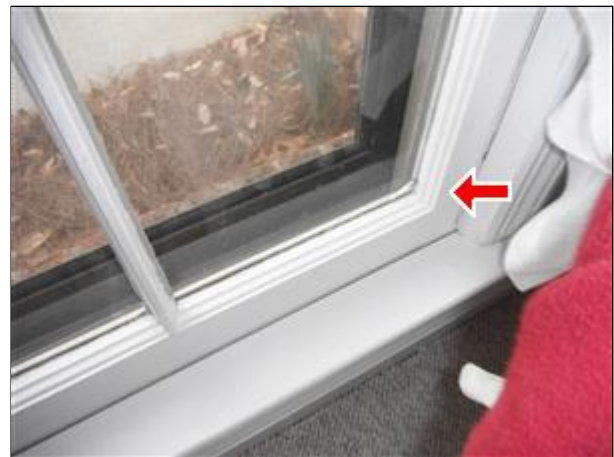
Front right bedroom window is stuck shut, won't open.

Front left bedroom window has a cracked window pane.

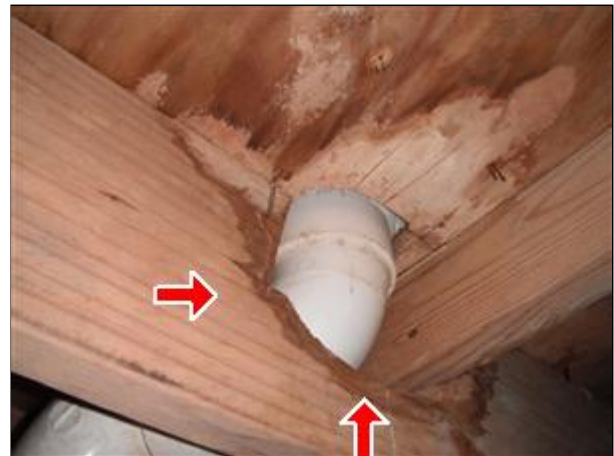
5.3 Picture 2 2

Floor system damaged

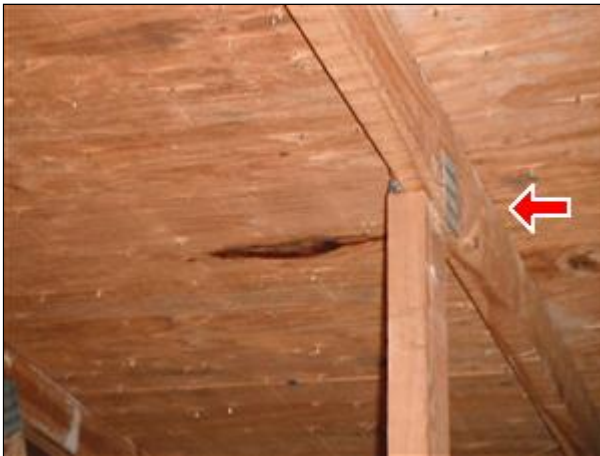
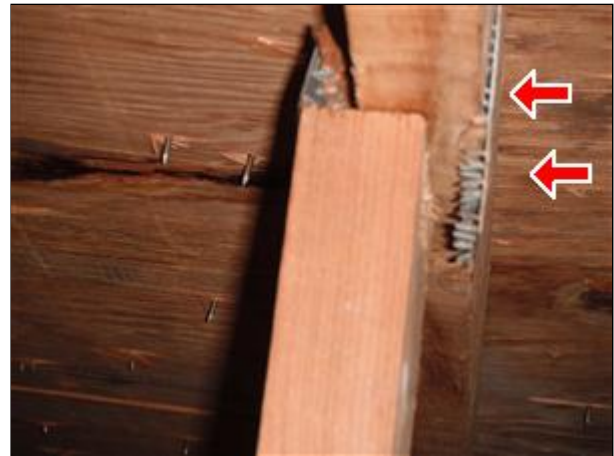
Truss framing in attic has a damaged metal truss gang nail plate, needs evaluation by a Lic. Engineer for any repairs.

Truss connection loose in attic.

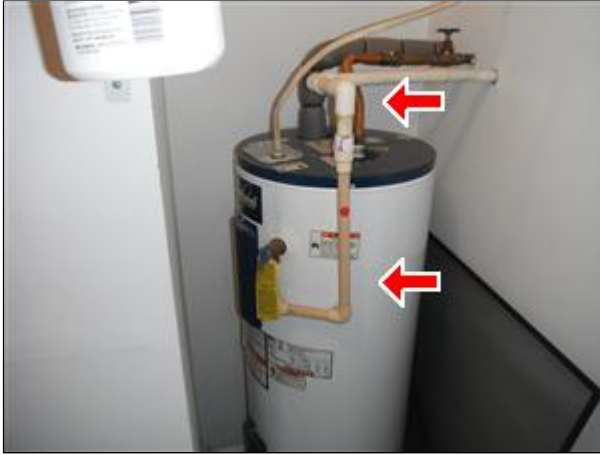
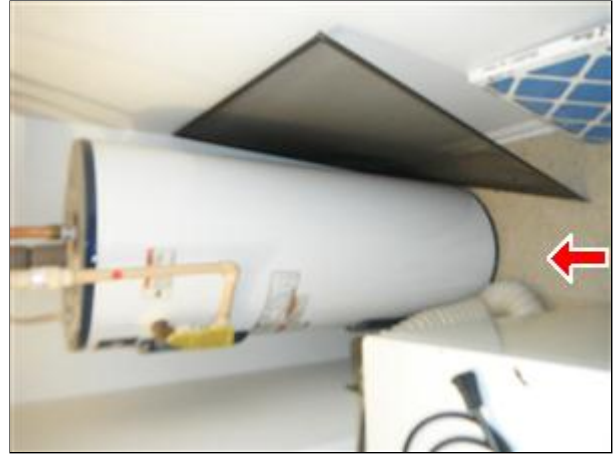
No drip pan under water heater, without a drip pan, if the water heater leaks water will cause damage to the floor covering and wood trim

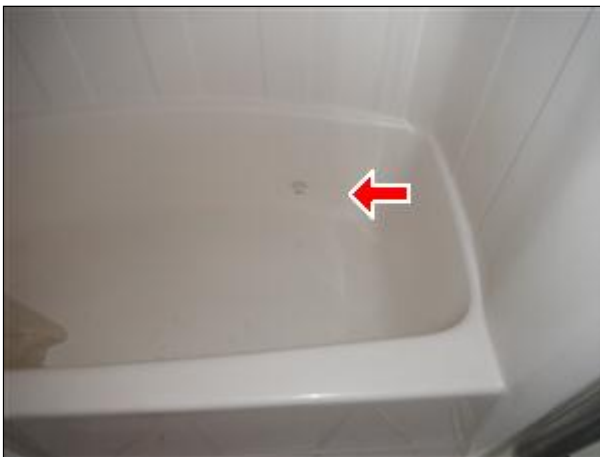
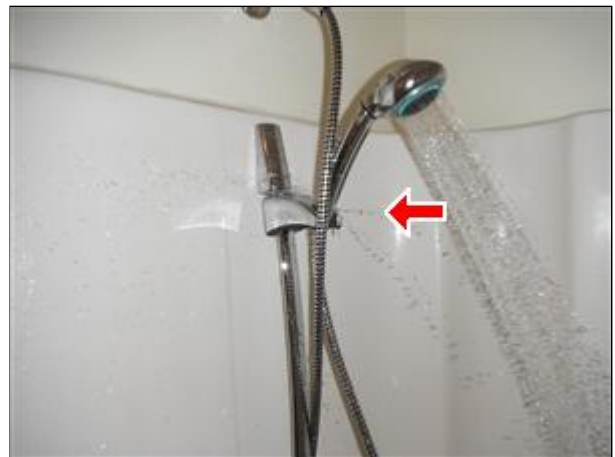
Old repaired area in master bathtub.

Mbath tub shower head leaks at the connection.

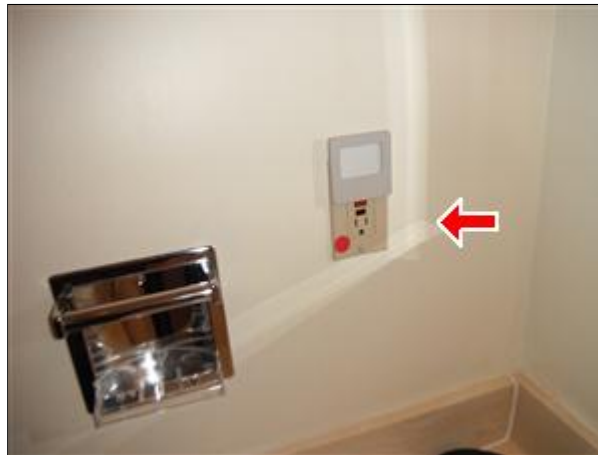
7.5 Picture 1

Master bath GFCI wall receptacle trips into the hall bath , needs to be corrected

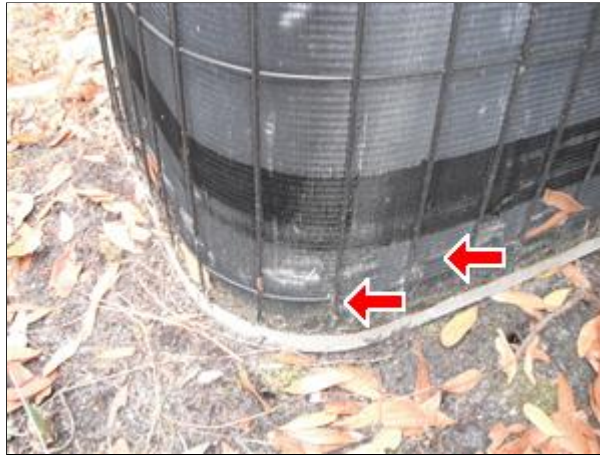
8.0 Picture 1

Outside unit fins have some damage.

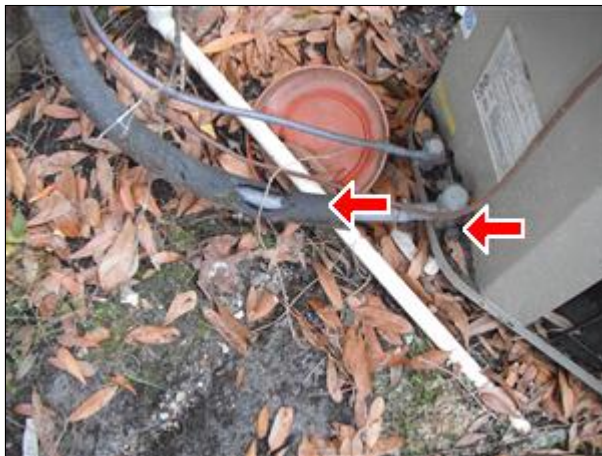
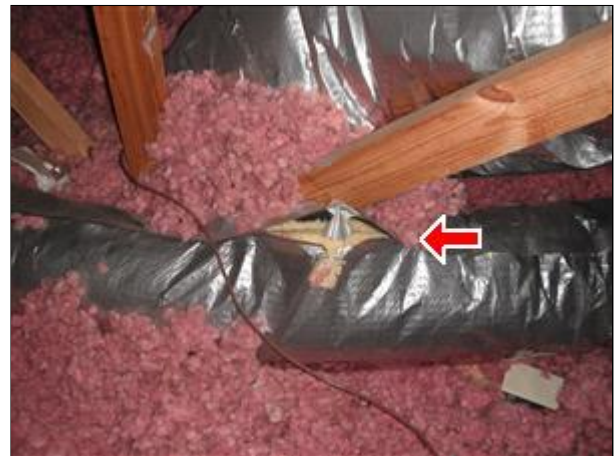
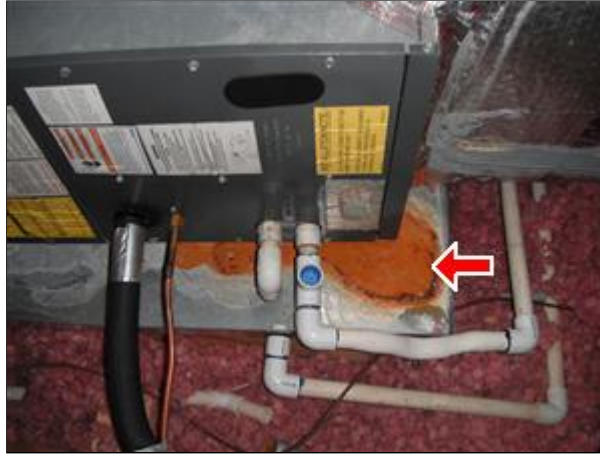
Outside compressor unit refrigerant line insulation is damaged.

Attic ductwork insulation is damaged , needs resealing.

Attic drip pan under the unit has some rusty areas in the pan.

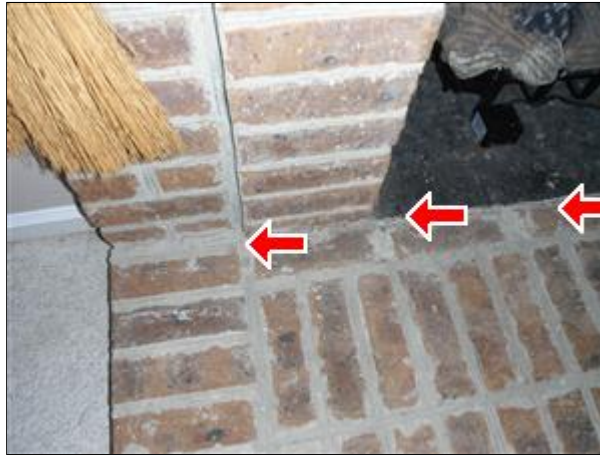
8.5 Picture 1

Brick hearth has settlement cracks in the grout.

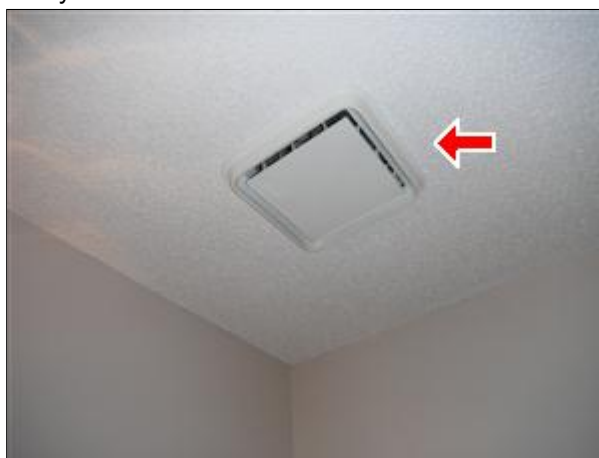
9.4 Picture 1

Hall bath ceiling exhaust vent is noisy and is not vented to the outside.
