# Inspection Report

## Happy Homeowner

45 Oak Dr.

<b>Date:</b> 2/21/2012	<b>Time:</b> 2:30 PM	<b>Report ID:</b> WCJ1202C019
<b>Property:</b> 45 Oak Dr. Charleston SC 29401	<b>Customer:</b> Happy Homeowner	<b>Real Estate Professional:</b>

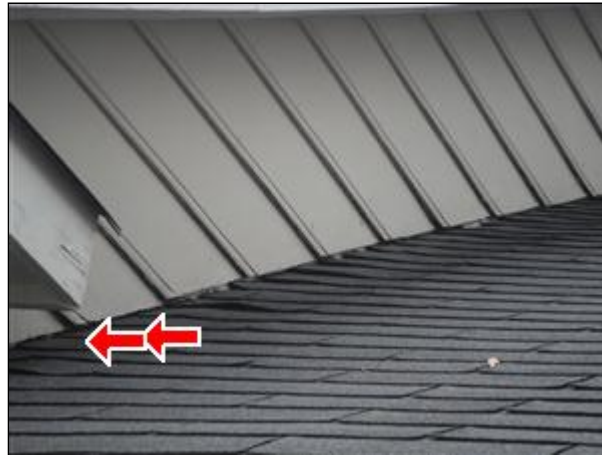
2.0 Picture 9

Shingles , siding doesn't have any clearance. Can cause some damage to the siding.

Chimney has settled, pulling away from the house, needs evaluation and repairs by a Qualified Lic. Contractor.

Hardboard siding is damaged from moisture on the rear of the home.

Hardboard siding is damaged on the left front corner.

Siding damaged from moisture on garage.

Hardboard siding is damaged on right side of the garage

Hardboard siding has small damaged areas where siding touches the shingles

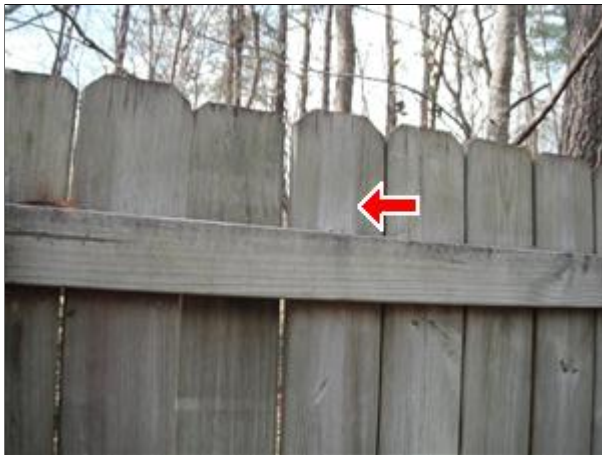
2.3 Picture 1

2.3 Fence boards warped, scattered in rear and side yard..

Outside storage shed steps don't have a hand railing, safety concern

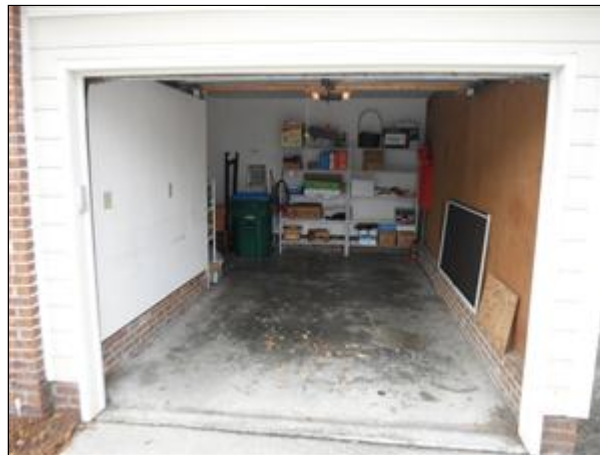
3.0 Picture 1

**3.3 Garage door metal panel , at the top of the door , is damaged**

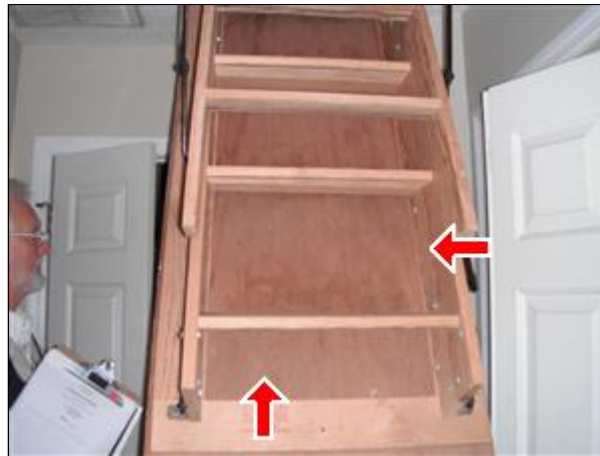
4.3 Picture 1

4.3 Attic pull down steps not insulated or weather-stripped.

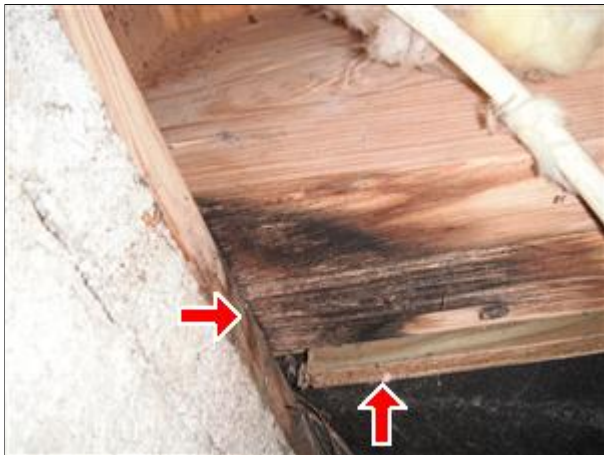
5.3 Picture 1 1

**5.3** Floor system damaged

Trade cut in floor system ,where plumbing was installed.

Floor system not supported properly, needs additional support.

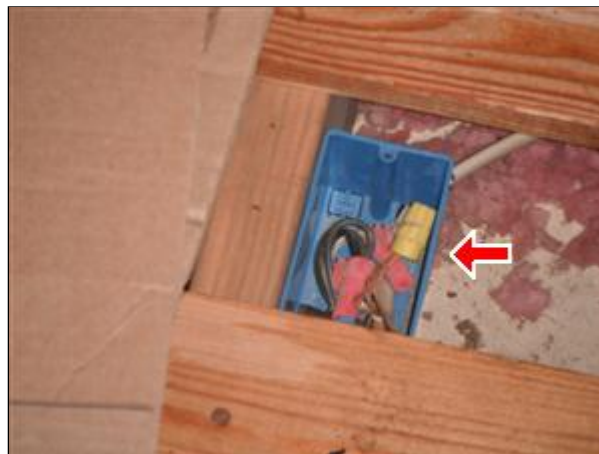
7.3 Picture 1

7.3 Open junction box in attic rear right , needs a cover plate for safety.

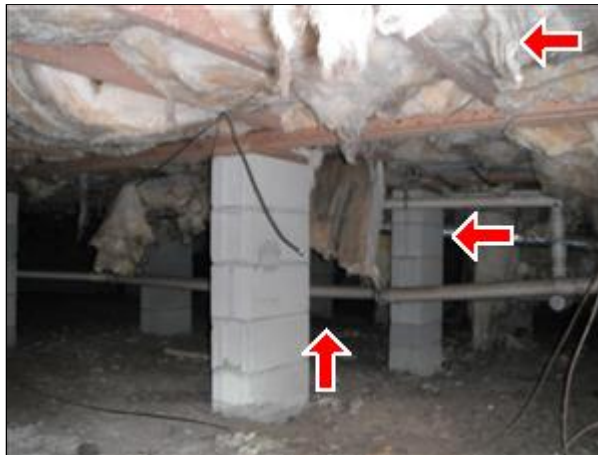
9.1 Picture 1

9.1 Floor system insulation falling down.

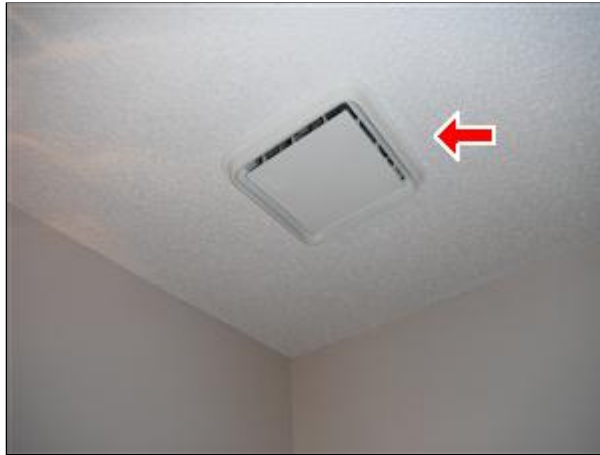
9.4 Picture 1

**9.4 Hall bath ceiling exhaust vent is noisy and is not vented to the outside.**

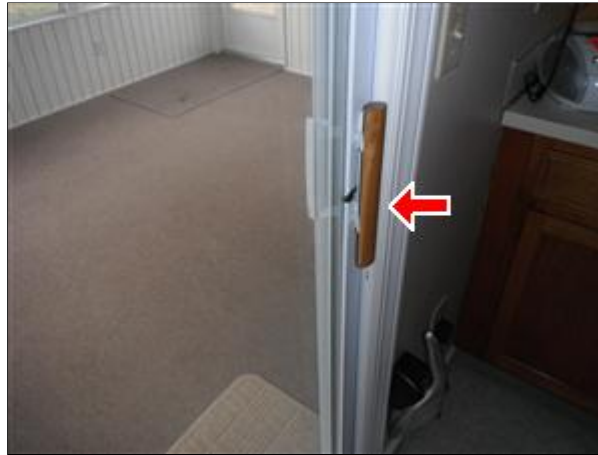
2.1 Picture 1

Rear slider door lock, latch needs adjustment.

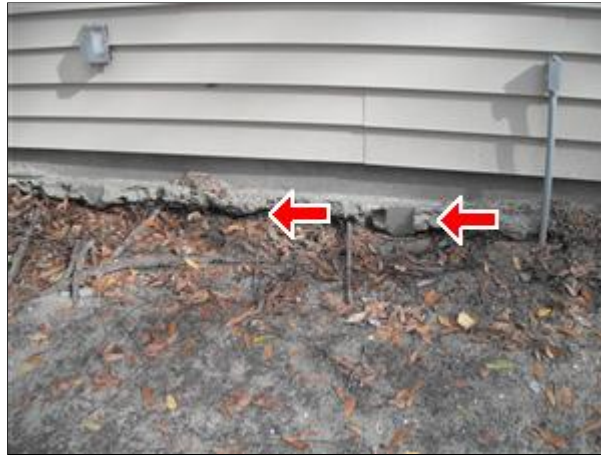
5.0 Picture 1

Rear sun room slab exposed , footings , needs backfilling with soil.

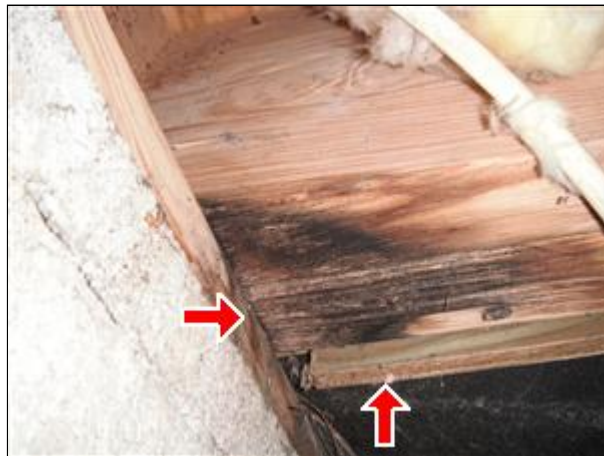
5.3 Picture 1 1

Trade cut in floor system ,where plumbing was installed.

Floor system not supported properly, needs additional support.

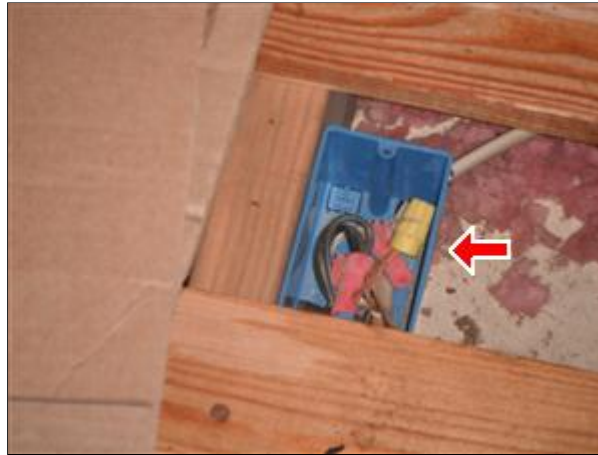
7.3 Picture 1

Open junction box in attic rear right , needs a cover plate for safety.

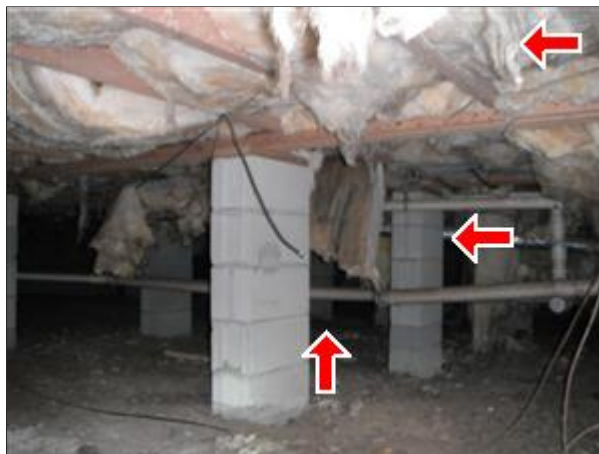
9.1 Picture 1

Floor system insulation falling down.
